NASA Contractor Report 191115

# Thermomechanical Fatigue Damage/Failure Mechanisms in SCS-6/Timetal 21S [0/90]<sub>s</sub> Composite

June 1994

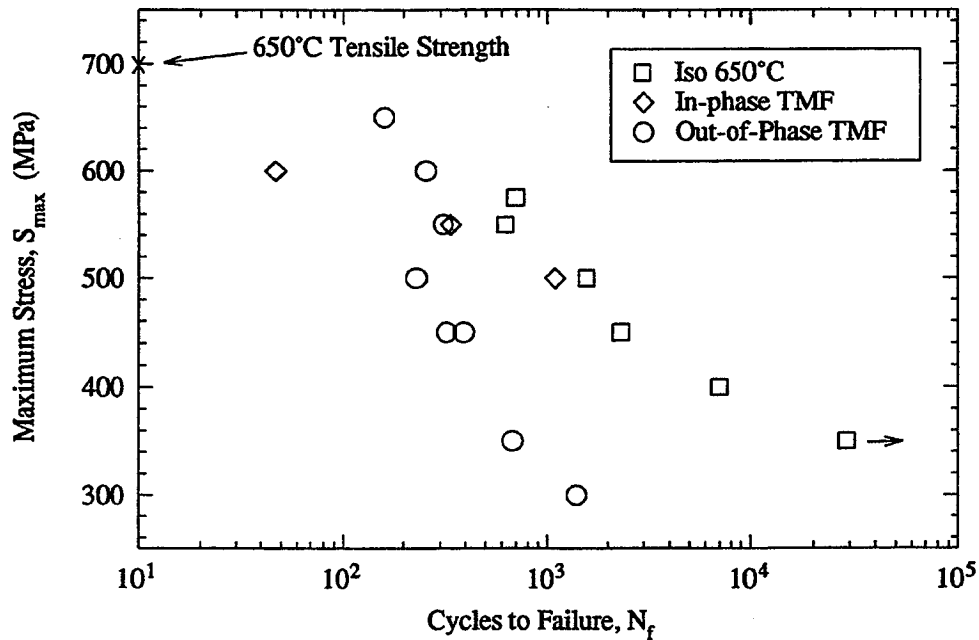
Figure 2. Thermomechanical fatigue life of SCS-6/Timetal 21S [0/90]<sub>s</sub> with a temperature cycle of 150-650°C.

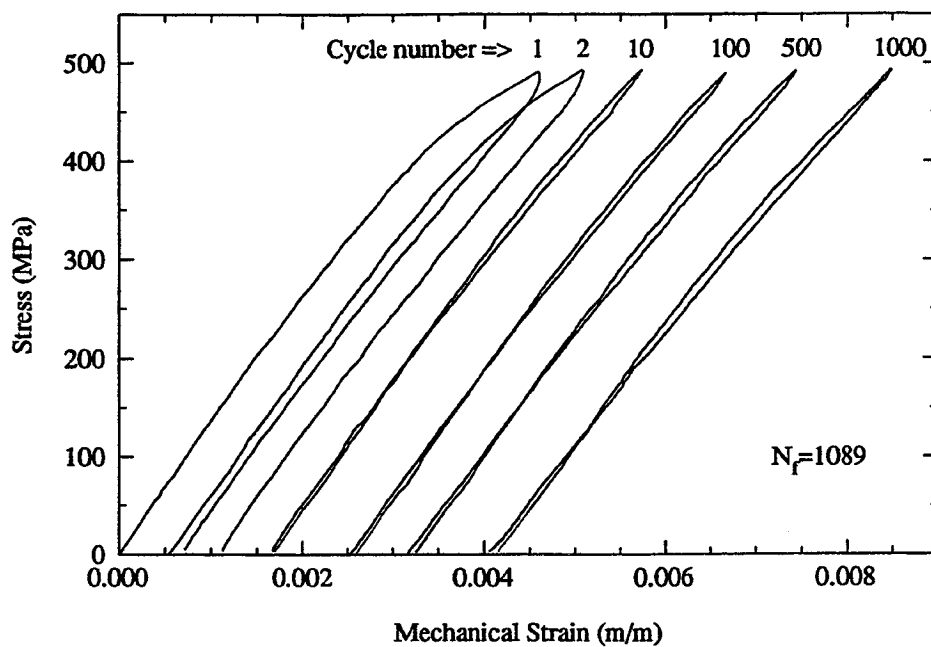
Figure 3. In-phase thermomechanical fatigue deformation of SCS-6/Timetal 21S [0/90]<sub>s</sub> with  $S_{\max} = 500$  MPa.

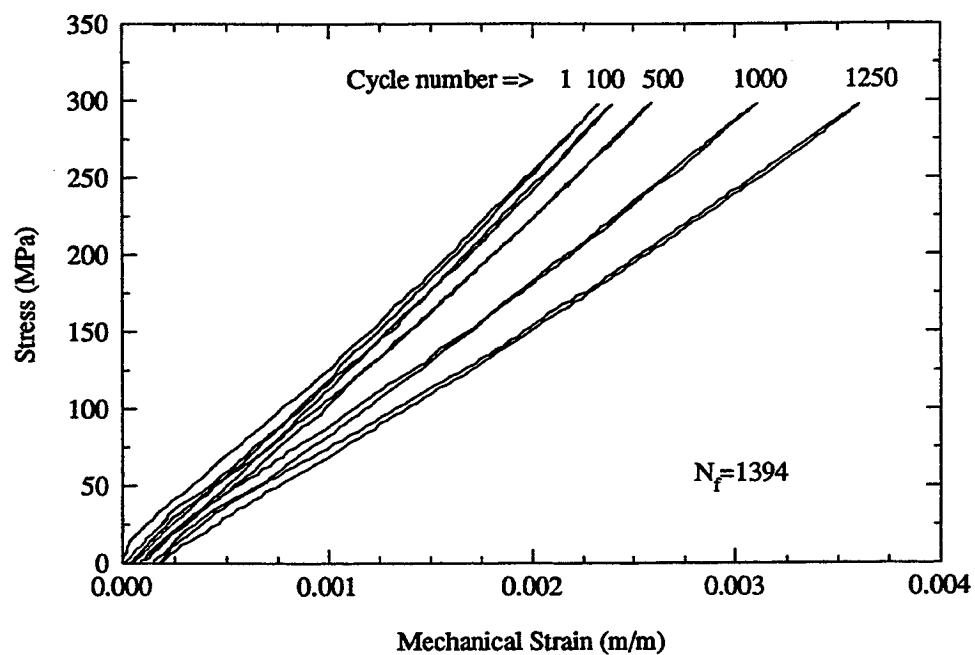
In contrast to IP and isothermal loadings, OP loadings did not promote excessive strain ratchetting, as OP maximum loading occurred at  $T_{min}$  where matrix load shedding and tensile strain ratchetting was less likely to occur. In similar fashion to Fig. 3, a representative OP deformation response is shown in Fig. 4 where the  $S_{max}$  value was 300 MPa; these conditions yielded a cyclic life comparable to the  $S_{max} = 500$  MPa IP test shown in Fig. 3. In general, only minor increases in minimum  $\epsilon^m$  occurred throughout the OP tests indicating the lack of strain ratchetting. The maximum  $\epsilon^m$  values, however, typically revealed clear increases, indicating decreases in the overall "TMF stiffness". This behavior is characteristically illustrated in Fig. 4 (quantitative values discussed subsequently). A note of caution is warranted when qualitatively interpreting this Fig., as the mechanical strain scale is quite different from Fig. 3, given the relatively small strains incurred during OP TMF tests. Note also that the loops exhibited a distinct convex curvature toward the right; this was promoted by the dynamically increasing stiffness with load and temperature, overriding the decreasing tangential stiffness trend which is normally associated with increasing load. As was the case for the IP deformation, no distinct knee was apparent in the stress-strain response.

Figure 4. Out-of-phase thermomechanical fatigue deformation of SCS-6/Timetal 21S [0/90]<sub>s</sub> with  $S_{\max} = 300$  MPa.

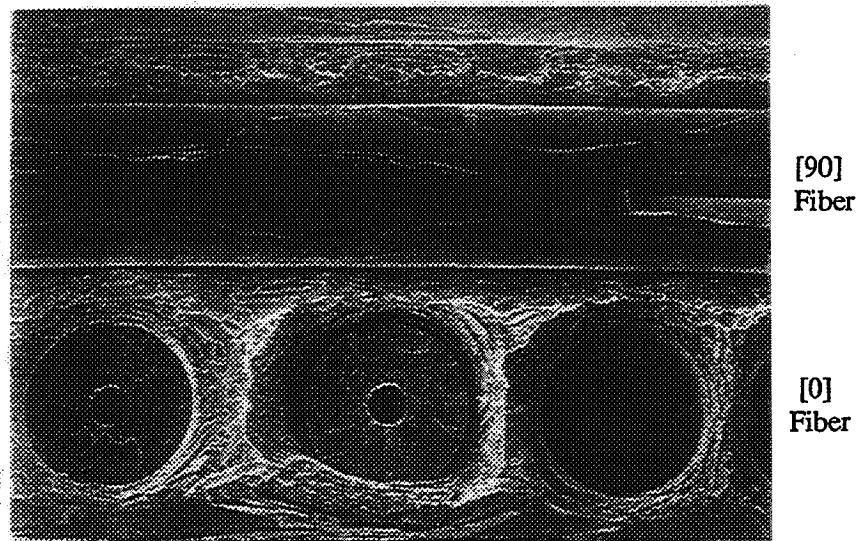
IP,  $S_{\max} = 500 \text{ MPa}$ ,  $N_f = 1\,089$  100  $\mu\text{m}$

Fracture surfaces taken from IP TMF specimens revealed distinct and unique features relative to those found under isothermal and OP conditions. All IP fracture surfaces exhibited ductile matrix failure over the entire cross-section as typically shown by the SEM fractography in Fig. 5. Matrix in contact with the [90] fibers revealed a relative increase in oxidation (based on discoloration), again confirming the oxygen "piping" effect noted under isothermal conditions. However, fatigue cracking initiated at the [90] F/M interfaces was not evident on the fracture surfaces. A relative increase in [0] fiber pullout was also visible. In general, all IP features closely resembled those produced by monotonic tensile failures, a trend which was also noted in [0] TMCs (Castelli et al., 1992).

Figure 5. SEM fracture surface highlighting the ductile matrix failure associated with IP TMF loading.

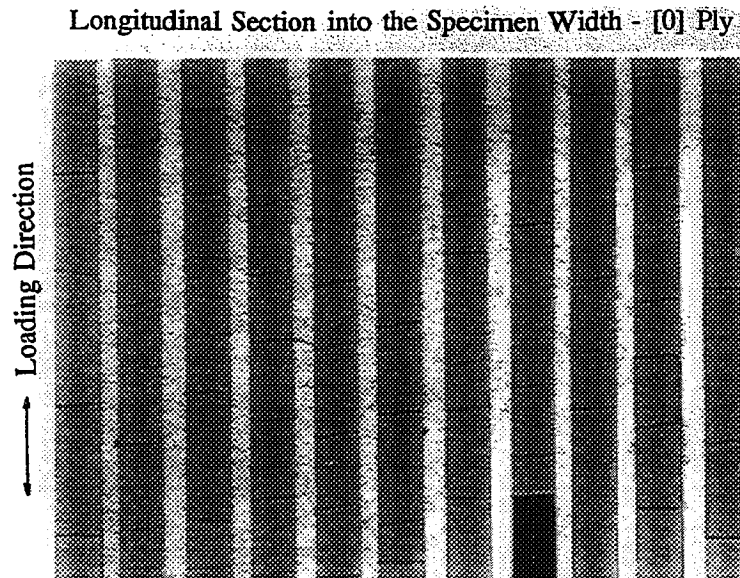
IP,  $S_{\max} = 550 \text{ MPa}$ ,  $N_f = 338$  200  $\mu\text{m}$

Comprehensive metallography on failed specimens revealed global de-bonding of the [90] fibers in the loading direction. Limited matrix cracks, predominantly transverse to the loading direction, were found to initiate at [90] F/M interfaces, but their relative size and number were greatly reduced from those produced under comparable isothermal and OP conditions. SEM of the specimens' surfaces revealed no surface cracking confirming the fractographic observations. Clearly, the dominant damage present under IP conditions was extensive [0] fiber cracking, as shown in Fig. 6 by the longitudinal section exposing a [0] fiber ply. The majority of fibers appeared to be broken into lengths of 200 to 400  $\mu\text{m}$ , suggesting a relationship to a characteristic load development length. Close inspections at high magnifications revealed that the cracks typically stopped (or began) at the interfaces of the outer carbon/carbon coating of the SCS-6 fibers and did not reach (or start at) the interfaces of the reaction zone/carbon coating. In these cases, the bond between the reaction zone and the outer carbon coating of the SCS-6 fiber appeared to be intact. Note, however, that the exact initiation points of the fiber cracks are unclear because the fibers were always found to be cracked across their full diameter. As was found under isothermal conditions, localized [0] fiber de-bonding and enhanced oxidation at the TiNb crossweave intersections were visible; however, these appeared to have no influence on [0] fiber cracking.

Metallography on IP test specimens interrupted prior to failure revealed that the [0] fiber cracking occurred relatively early in cyclic life. Under IP TMF conditions with  $S_{\text{max}} = 500 \text{ MPa}$ , [0] fiber cracking was visible at the earliest interrupted value of 200 cycles, that is,  $\approx 20\% N_f$ . This observation is consistent with a study by Neu and Roman, (1993), where TMF damage in a unidirectional TMC was monitored through acoustic emissions. Their work indicated that a number of [0] fiber fractures occurred within the first 2 cycles of an IP test where  $N_f > 4000$  cycles.

Figure 6. Metallographic section showing extensive [0] fiber cracking associated with IP TMF loadings.

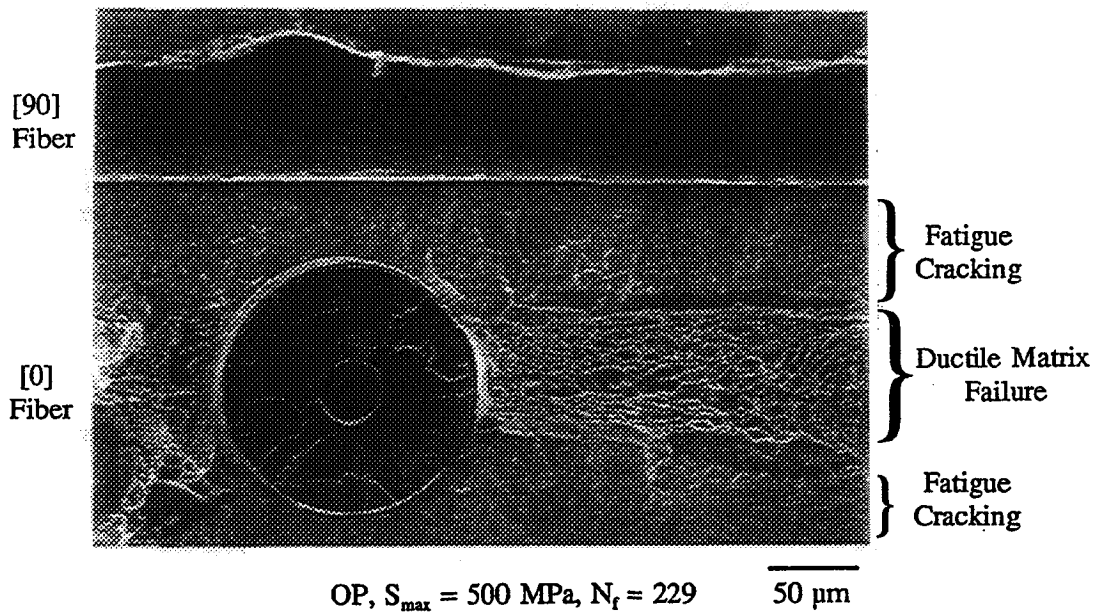
OP TMF conditions introduced a mechanism not present under  $650^\circ\text{C}$  isothermal or IP TMF loadings, namely, surface initiated fatigue cracking. Fracture characteristics and oxidation patterns strongly suggested crack initiation points at both surface and [90] F/M interface locations. Oxidized cracks initiated at the surface appeared to propagate transversely (i.e., through the thickness) in toward the [0] fibers, and oxidized cracks initiated at the [90] F/M interfaces propagated transversely out toward the [0] fibers. Upon failure, a "strip" of matrix exhibiting ductile failure characteristics was created along the centerline of the [0] fibers. This failure mode is shown in Fig. 7. Note the foil/foil interface at the center of the ductile strip; this defines what is referred to as the "centerline" of the [0] fiber. These ductile strips were most notable under high and mid  $S_{\text{max}}$  levels. Under relatively low  $S_{\text{max}}$  conditions, surface initiated and [90] F/M interface initiated cracks were able to meet at the [0] fibers prior to overload failure, exhibiting fatigue fracture surfaces which were cracked through the entire thickness.

Figure 7. SEM fracture surface showing transverse fatigue cracking in from the surface and out from the [90] F/M interfaces forming a ductile matrix "centerline strip" along the [0] fibers upon failure.

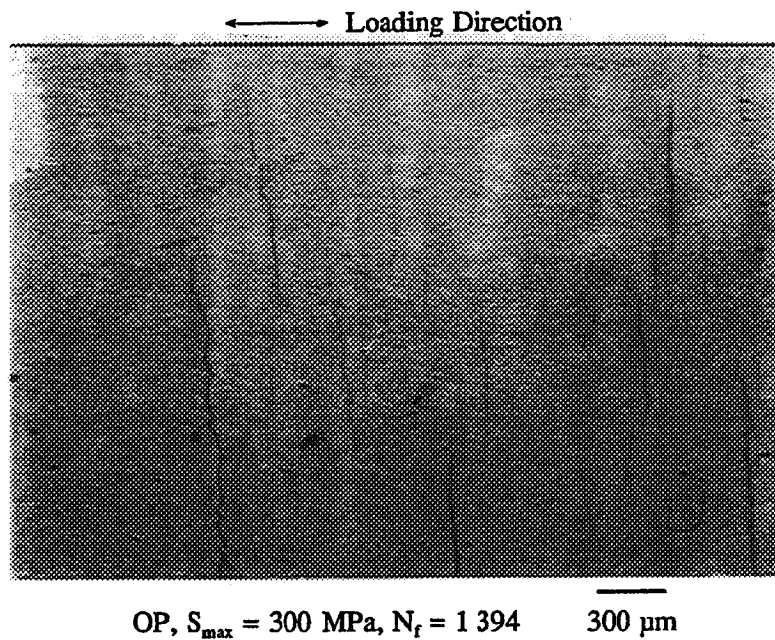
SEM of OP specimen surfaces and thorough metallography confirmed the fracture surfaces' indications. Extensive surface cracking transverse to the loading direction, such as that shown in Fig. 8, was evident over the entire gage section for all OP conditions. In general, the number of visible surface cracks increased with increasing  $S_{max}$ ; however, relatively low  $S_{max}$  conditions tended to produce cracks exhibiting a more tortuous path with increased crack branching. By longitudinally sectioning into the thickness of the specimen, it was evident that cracks were propagating both in from the surface and out from the [90] fibers. This is exhibited in Fig. 9 where several secondary cracks are shown that had not yet propagated through the entire thickness. The majority of [90] fibers exhibited multiple crack initiations. Close examination of these secondary cracks revealed apparent initiation points at both the *i*) interfaces of the outer carbon/carbon coatings of the SCS-6 fibers, and *ii*) interfaces of the reaction zone/carbon coating. As previously observed under IP conditions, all [90] fibers exhibited some degree of de-bonding in the loading direction. Sections exposing the [0] ply revealed a complete absence of [0] fiber cracking. The only damage associated with the [0] fiber was localized de-bonding and enhanced oxidation coinciding with the TiNb crossweave, as found in isothermal and IP tests. However, this appeared to have no influence on the matrix cracking.

Figure 8. SEM surface picture showing extensive surface cracking associated with OP TMF loadings.

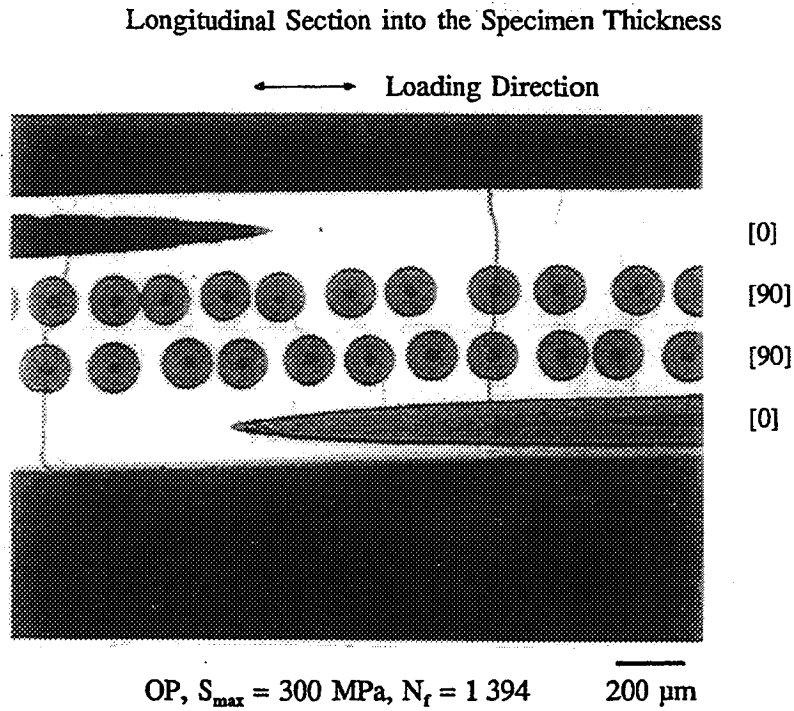
Metallography on OP test specimens interrupted prior to failure revealed that both surface and [90] F/M interface initiated cracks occurred extremely early in cyclic life. A specimen interrupted as early as 7% of the expected cyclic life (i.e.,  $N = 100$  with an expected  $N_f = 1394$ ) revealed several small surface cracks and multiple [90] F/M interface initiated cracks. All of the [90] fibers exhibited F/M de-bonding in the loading direction, as this likely occurs on the first cycle.

Figure 9. Metallographic section showing matrix cracks initiated at both surface and [90] F/M interface locations.

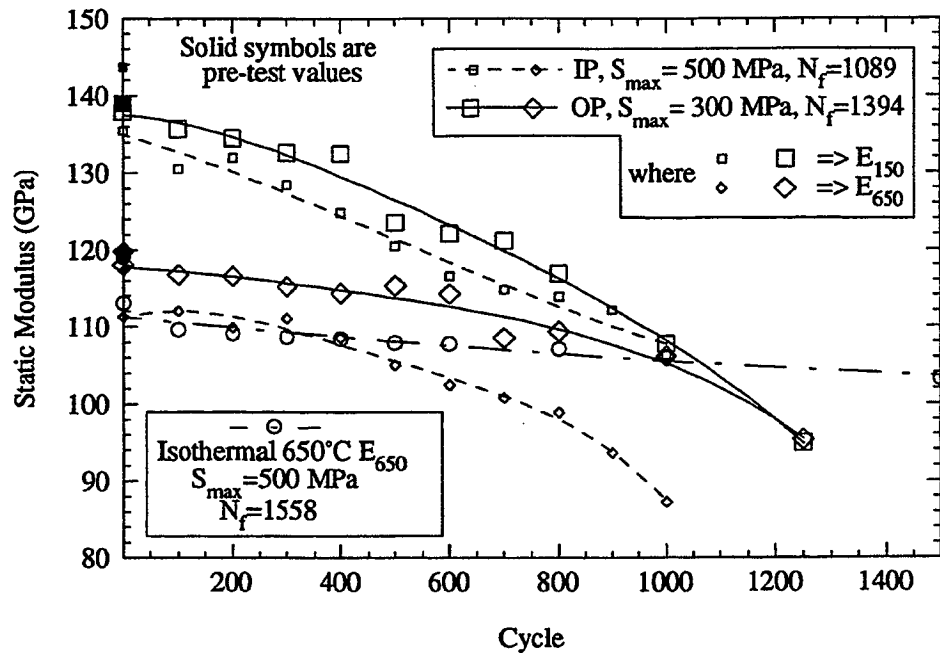
Shown in Fig. 10 are the isothermal moduli ( $E$ ) measurements collected for the two TMF experiments whose deformation behaviors were previously discussed (Figs. 3 and 4). These two stress levels were again selected to show stiffness degradations under IP and OP conditions resulting in comparable TMF lives. Each TMF test is represented by two curves consisting of the isothermal  $E$  values measured at the temperature extremes of the TMF cycles, i.e.,  $E_{150}$  and  $E_{650}$ . Also shown in this plot are the  $E_{650}$  values taken from an isothermal test at 650°C with an  $S_{max}$  value of 500 MPa. Several key observations can be made concerning the damage progression.

First, it was obvious that the damage accumulation, in terms of stiffness degradation, changed with cycle type. This is reasonable given that observations from the fractography and metallography indicated distinct differences. Under IP TMF conditions with  $S_{max} = 500$  MPa, first cycle degradation was evident (a 6% drop), and quantitatively very similar to those found under 650°C isothermal fatigue conditions (shown) and OP TMF conditions (not shown) with  $S_{max} = 500$  MPa. For all tests conducted on this material, the degree of initial stiffness degradation was more closely related to  $S_{max}$  rather than cycle type, and in general, was found to increase with increasing  $S_{max}$ . It is likely that this initial stiffness degradation is strongly associated with the [90] F/M de-bonding. As stated earlier, one advantage of this test technique was that it allows for direct quantitative comparisons between isothermal and TMF damage based on stiffness degradation. By comparing the  $S_{max} = 500$  MPa IP TMF and 650°C isothermal tests, one notes that although the lives are not dramatically different (see Fig. 2) and the first-cycle  $E_{650}$  degradations are essentially identical, the damage progression is

Fig. 10 also indicates that the IP loading condition promoted similar degradation behaviors in the  $E_{150}$  and  $E_{650}$  values, as represented by the fairly constant gap between the two dashed lines. The data suggest that the ongoing composite damage is impacting the "low" temperature stiffness in much the same way as it is impacting the "high" temperature stiffness. Recall from above that the dominant progressive damage under IP conditions was [0] fiber cracking associated with a lesser degree of matrix damage at the de-bonded [90] interfaces. Also note that the stiffness of the SCS-6 fiber is relatively insensitive to temperature over this temperature range (Textron Specialty Materials). If the broken [0] fiber segments are sufficiently small and/or sufficient de-bonding occurs along the damaged [0] fibers, in turn compromising the load transfer, the effective contribution of the fiber stiffness to the composite stiffness will be degraded. Such a reduction of the effective fiber contribution to the composite stiffness will promote quantitatively comparable reductions at 150 and 650°C. This, essentially, is the trend established by the IP damage progression, quantitatively characterized in Fig. 10.

In contrast to the IP behavior, the E values measured from the OP specimen did not degrade equally, but rather, the  $E_{150}$  or "low" temperature E values degraded more severely. This trend was most evident under mid to low  $S_{max}$  values where the progression of matrix cracking through the cross-section was sufficiently "mature" prior to the effective overload failure. For the OP test presented in Fig. 10 (i.e.,  $S_{max} = 300$  MPa), the composite E values at both temperature extremes were essentially equal just prior to failure where the material is in a highly damaged state. Qualitative information from the fractography and metallography discussed above indicated that environment enhanced matrix fatigue cracking was the primary damage mechanism, with little or no [0] fiber cracking. Considering again a straightforward interpretation of the composite stiffness based on constituent contributions, one notes that the matrix contribution is much greater at 150°C than at 650°C. This comes from the fact that the stiffness of the Timetal 21S matrix (unlike the SCS-6 fiber) is strongly dependent upon temperature in this temperature range (Castelli et al., 1994). Given this, and considering a continual degradation of the effective matrix stiffness in the absence of [0] fiber cracking, the relative degradation of the composite  $E_{150°C}$  values will be greater than that experienced by the composite  $E_{650°C}$  values. Further, in the extreme case where the matrix is "completely" damaged and contributes nothing to the composite stiffness, the composite E values at both temperature extremes will be essentially equal, given that the SCS-6 fiber stiffness is relatively insensitive to temperature over this temperature range. In agreement with the microstructural observations, this appears to be the progression of damage quantitatively characterized by the data given in Fig. 10.

Figure 10. Degradation of the isothermal static moduli at 150 and 650°C during IP and OP thermomechanical fatigue of SCS-6/Timetal 21S [0/90]<sub>s</sub>.

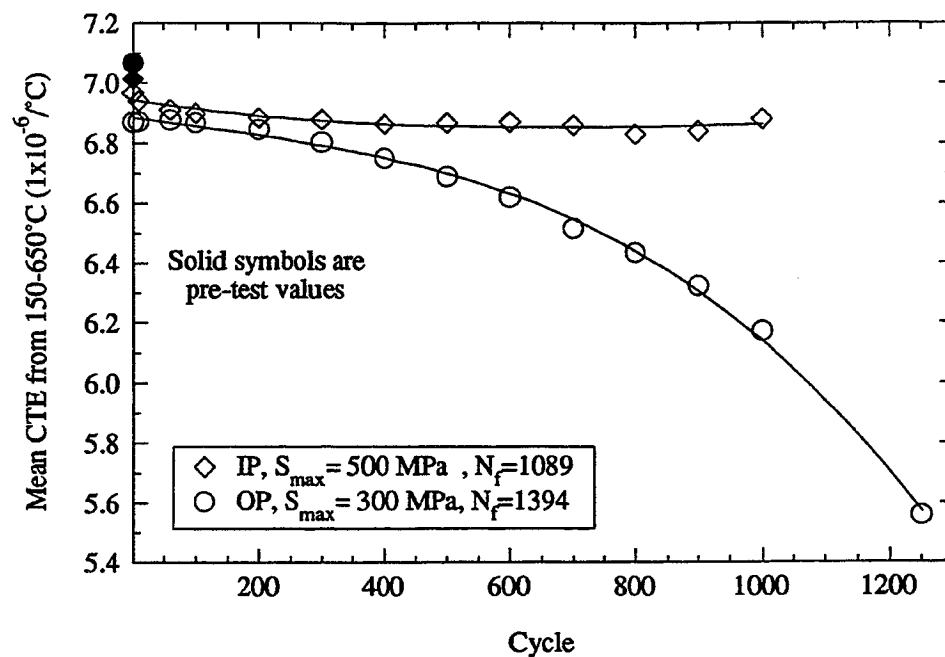
Degradations of the mean CTEs are shown in Fig. 11 for the IP and OP tests discussed in Fig. 10. The mean CTE was calculated by taking the  $\epsilon^{\text{th}}$  range from 150 to 650°C and dividing it by  $\Delta T$ , that is, 500°C. Thus, it represents the average CTE for the TMF temperature cycle. In general, damage resulting from IP TMF loadings produced a relatively small decrease in the mean CTE early in cyclic life. However, this property appeared to stabilize and remain essentially constant throughout the cyclic life of the specimen. Although a significant degree of stiffness degradation was taking place as a likely result of [90] F/M de-bonding and damage associated with [0] fiber cracking, it appears that the impact of this type of damage on the macroscopic CTE is minimal.

In contrast, cyclic damage resulting from OP TMF conditions appeared to have a notable effect on the composite CTE. Degradation of this macroscopic property was again most pronounced and severe under mid to low  $S_{\text{max}}$  values (i.e., conditions which resulted in relatively long lives). Fig. 11 illustrates that under OP conditions with  $S_{\text{max}} = 300$  MPa, this property experienced a degradation of 22%. The extensive matrix damage in the presence of undamaged [0] fibers allowed the composite mean CTE to tend towards the lower CTE dictated by the [0] fibers. The magnitude of degradation will of course be strongly influenced by the relative percentage of [0] fibers and the remaining transverse stiffness imposed by the [90] fibers. It is apparent that under loading conditions which promote extensive matrix cracking, measurement of the CTE degradation provides a straightforward quantitative means for tracking the progression of composite damage. This was also found to be the case for similar [0] (Castelli, 1994b) and [90] (Castelli, 1993a) unidirectional TMCs subjected to TMF loadings. This type of information should also be extremely useful for the verification of analytical damage modeling for this class of materials.

Figure 11. Degradation of the mean coefficient of thermal expansion from 150 to 650°C during IP and OP TMF of SCS-6/Timetal 21S [0/90]<sub>s</sub>.
